WADC TECHNICAL REPORT 53-185

A STUDY OF THE RAIN EROSION OF PLASTICS AND METALS

ROY R. LAPP
RAYMOND H. STUTZMAN
NORMAN E. WAHL

CORNELL AERONAUTICAL LABORATORY, INC.

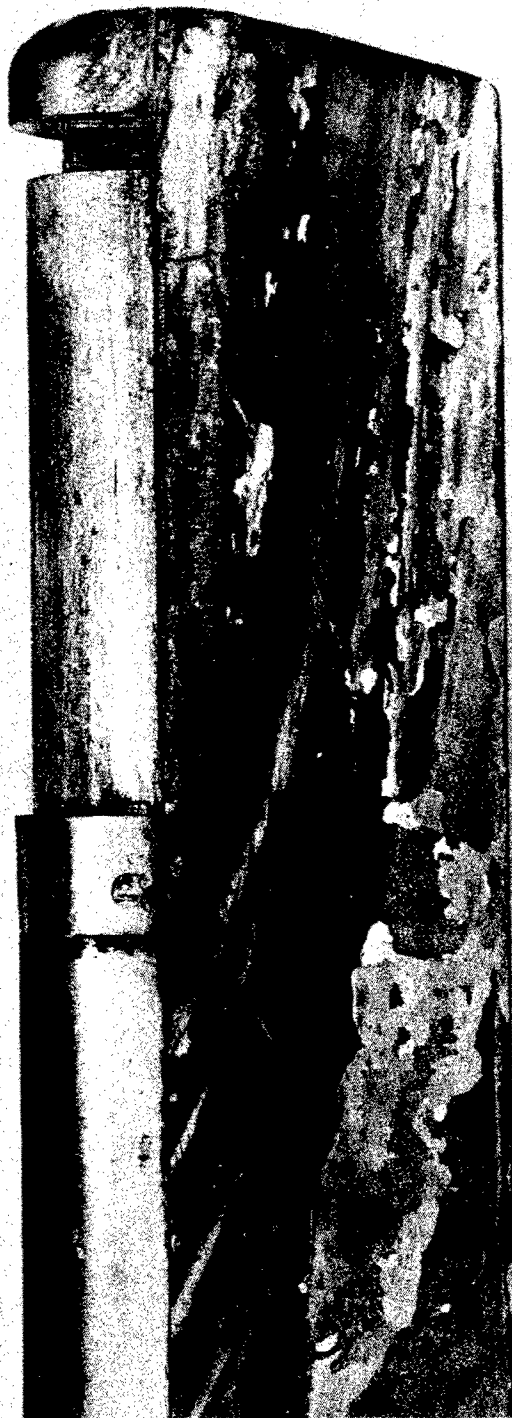
Figure 20 View of High Speed End of Whirl Test Blade, Showing Erosion
of Clips and Scale That Precipitated on Blade During High Speed Runs

VIEW OF TEST BLADE
SHOWING ACCUMULATION OF SCALE

After the whirl test blade had been in use for eighteen months with little maintenance other than polishing with steel wool and the installation of new stainless steel clips, it was decided that the test blade should be overhauled. The high speed end of the blade with the aluminum trailing edge had deposits of calcium salts that were almost 1/16" in thickness and very hard and brittle, similar to boiler scale. The appearance of the blade is shown in Figure No. 20. Upon removal of this scale it was found that the aluminum in the area where it made a butt joint with the steel portion of the blade had eroded badly. In addition, the stainless steel clips that held the specimen as well as the tip of the blade were eroded to such a degree that they were collapsing. The chrome plating on the underside of the blade was pitted and pin point areas of rust were observed. The blade was sent into the shop for removal of the aluminum trailing edge so that the copper and chrome plating could be stripped and the blade replated.
